# FRACTURE AND FAILURE OF NATURAL BUILDING STONES

Applications in the Restoration  
of Ancient Monuments

STAVROS K. KOURKOULIS

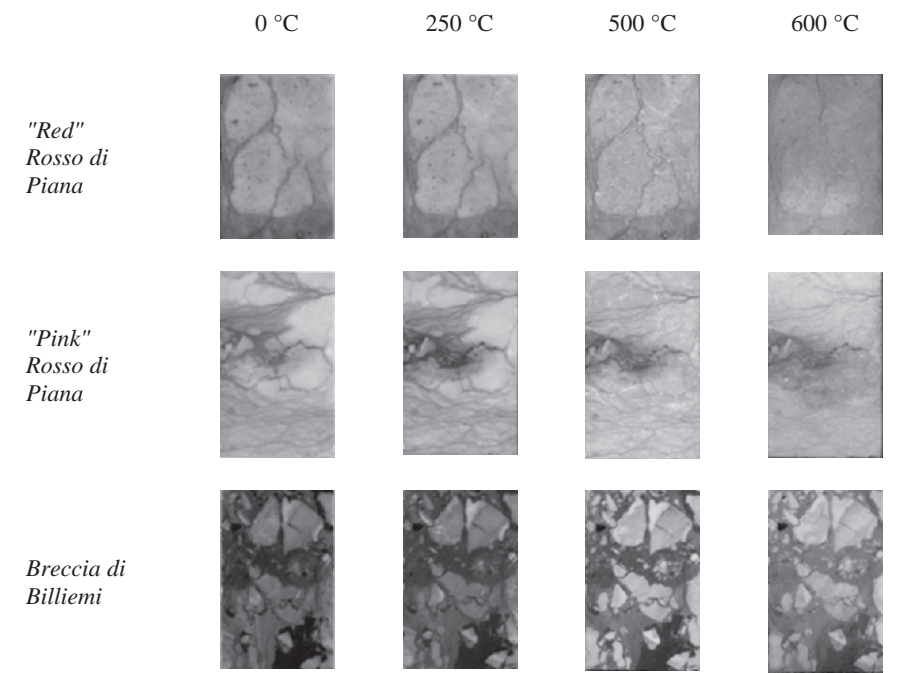
Figure 3. Effects of step by step heating on *Breccia di Billiemi* and *Rosso di Piana* slabs.

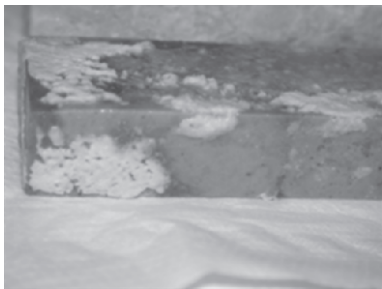
Figure 4. Deliquescent brina due to the acid attack on red Rosso di Piana slabs.

The acid attack produces similar degradation effects on both lithotypes, *Breccia di Billiemi*<sup>6</sup> and *Rosso di Piana*. After ten days exposure to vapours of hydrochloric acid and moisture an highly deliquescent brine drops out from the veins on both the varieties of *Rosso di Piana*, Figure 4, and the grain surface appears to be dull due to a mild corrosion. The samples were photographed after rinsing with fresh water, showing that red veins were corroded.

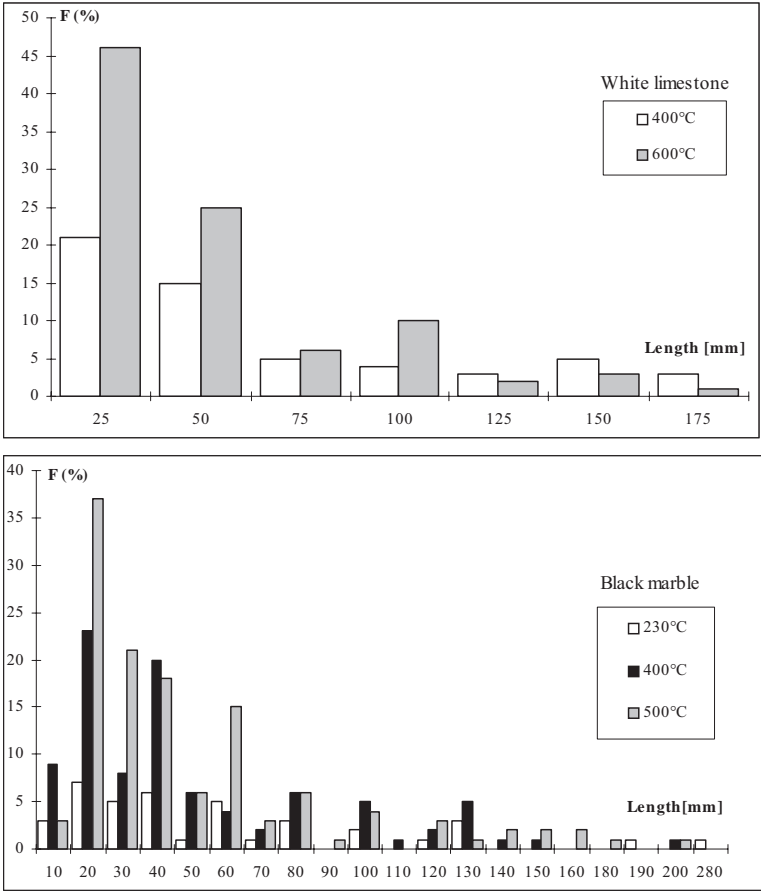
Figure 11. Crack length distributions measured on polished sections of White limestone and Black marble treated at various temperatures.

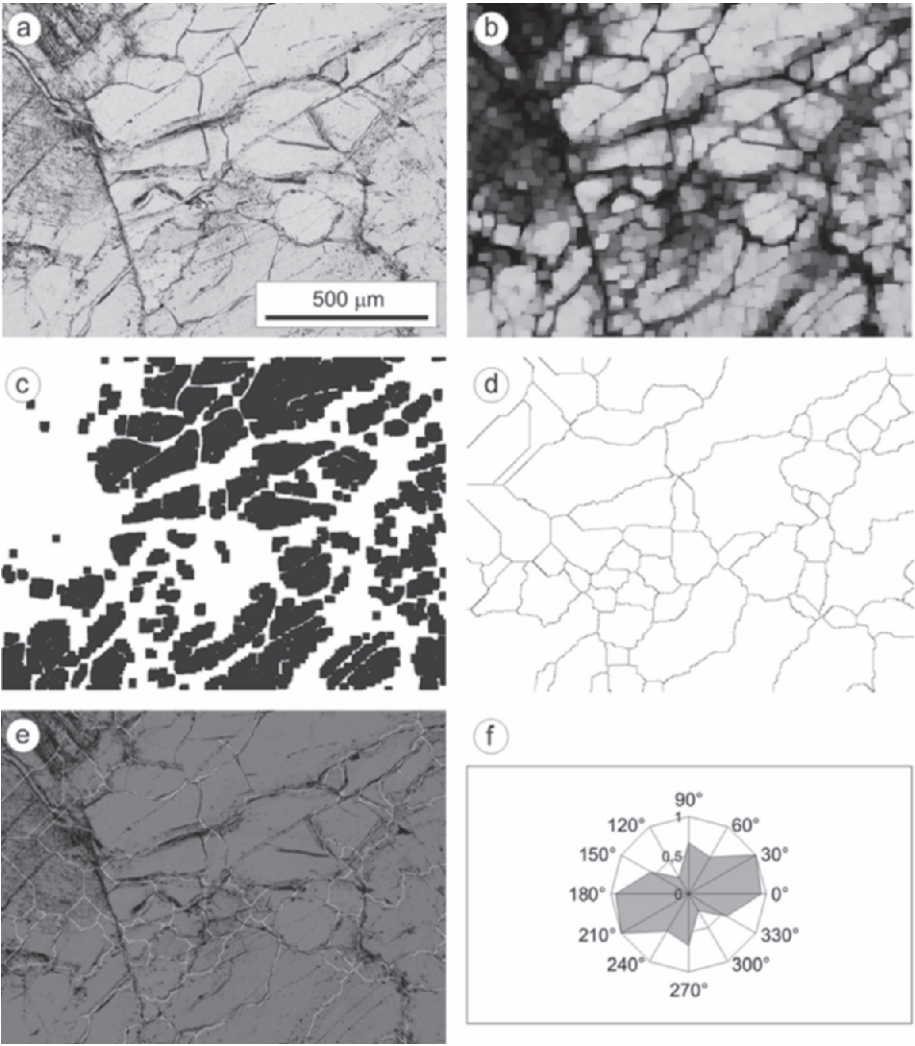
Figure 1. (a): Original image obtained with polarizing microscope (parallel nicols): grey level image; (b): Result of an opening performed on the image (a); (c): Binary image obtained by performing a “black top-hat” transform on the image (b); (d): Result of performing a “skiz” transform on the background of the image (c); (e) Composite image obtained by combining the original image a and the refined, cleaned and simplified binary image (d). The different fracture types could be identified in this image. (f): Rose of directions diagram for the whole fracture system pattern detected on the original image.

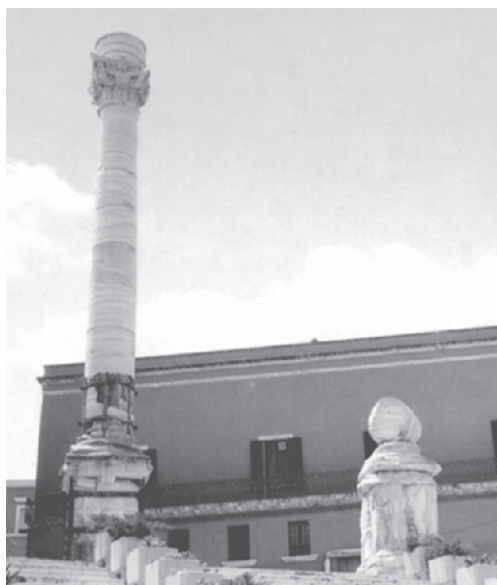
*Figure 1.* The terminal columns of the Via Appia in Brindisi. On the right the pedestal of the column fell down in 1528.

The terminal columns of the ancient Via Appia in Brindisi, standing in front of the port, are two (Figure 1). They represent an example of civil roman building in marble. One of the columns, named “cut off”, is reduced at present to the pedestal after the ruin of its shaft in 1528; it is referred that the fall was caused by an earthquake but in the General Catalogue of Italian Earthquakes a *sisma* is mentioned in the previous year (1527). Vice versa the “entire” column reaches 19 meters in height.

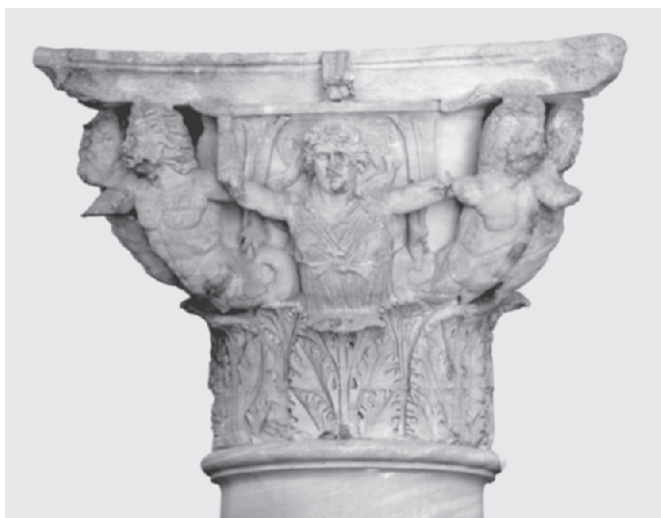
*Figure 2.* The capital (Proconnesium marble) decorated with the busts of Jupiter, Neptune, Pallas and Mars and by eight tritons.

The shaft of this column as well as the pedestal is of marble blocks; it supports a marble capital decorated with busts of Jupiter, Neptune, Pallas and Mars and by eight tritons (Figure 2). These sculptures, which belong to the Age of the Antonines, originate in the 1<sup>st</sup> or 2<sup>nd</sup> century A.D. The capital holds a dossier which probably supported a statue. Owing to the fracturing rate and the decay of the pedestal, the shaft was dismantled on precaution in 1997.

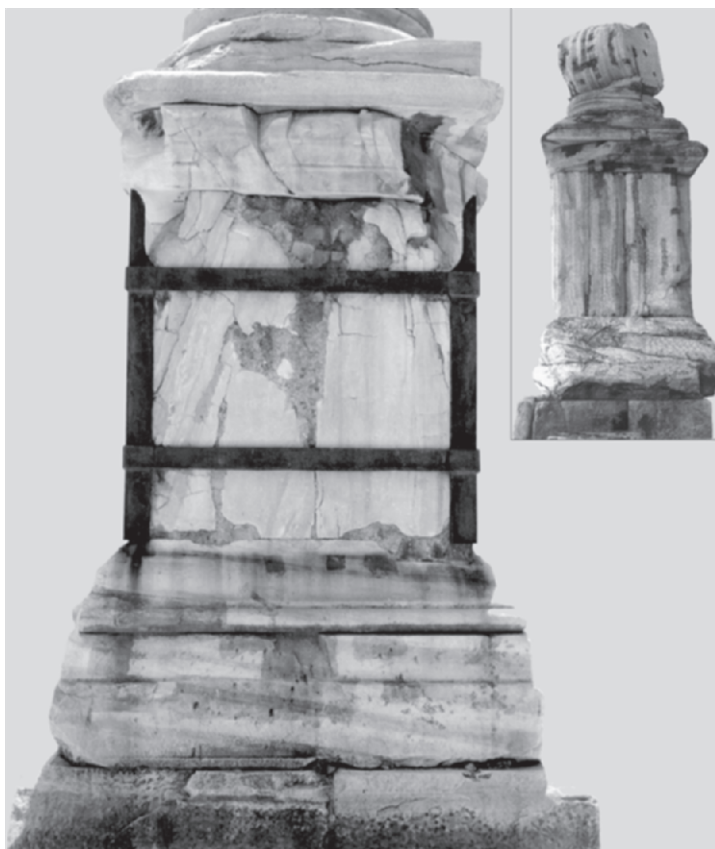
Figure 3. The fractured pedestal which supports the shaft of the column (19 m high).

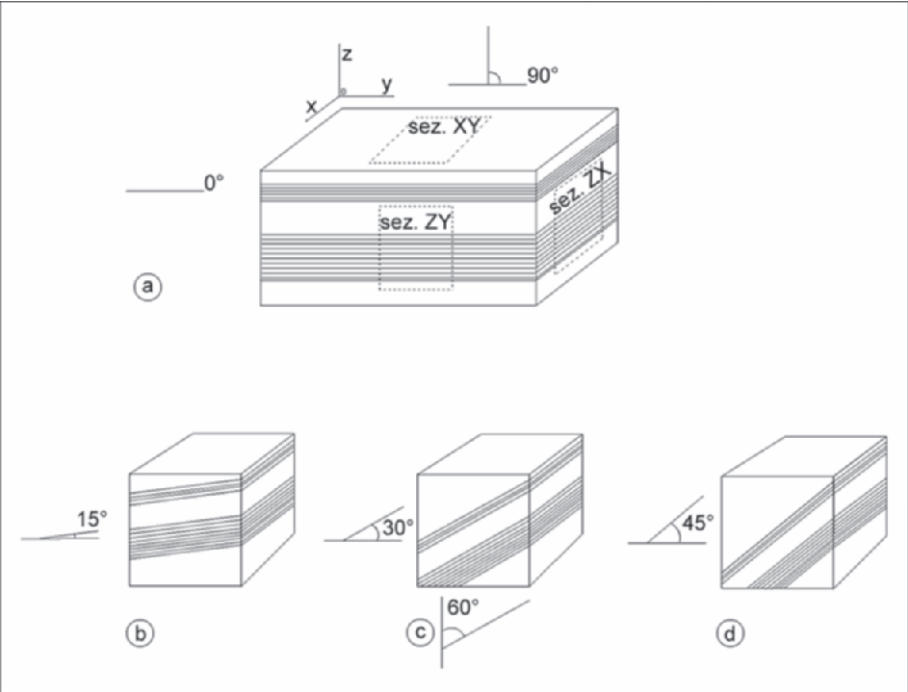
Figure 9. Ultrasonic measurements (direct method) parallel and perpendicular to the foliation (a) or with different values of inclination (b, c, d).

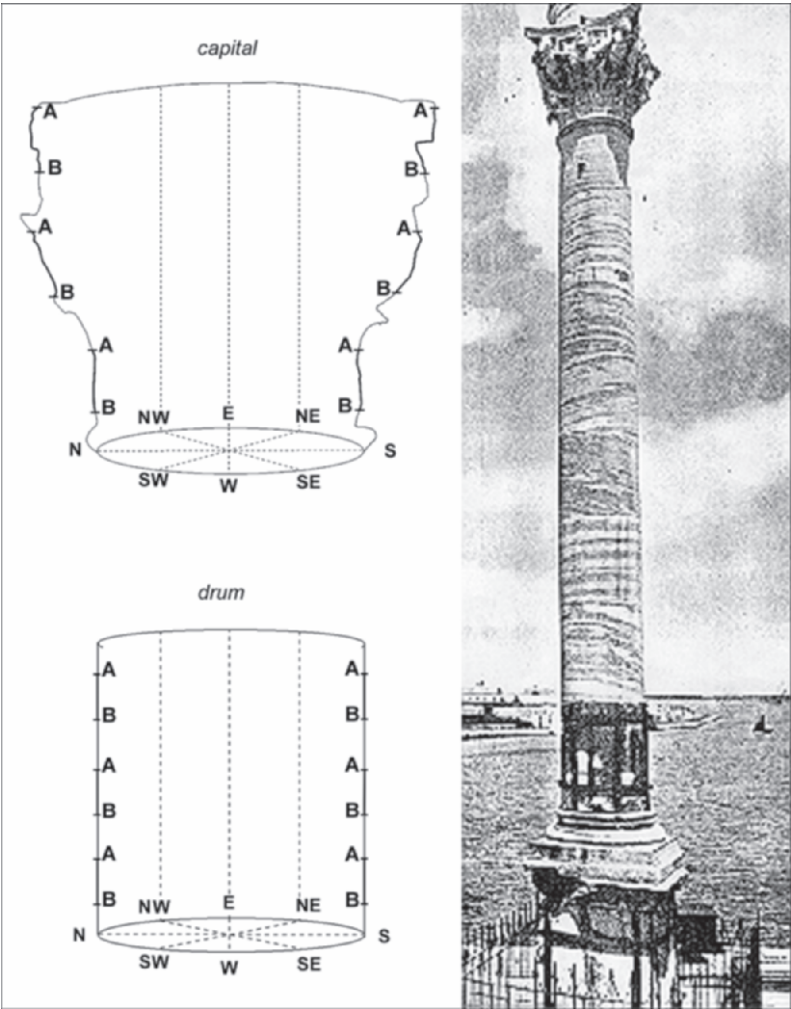
Figure 14. Plan of the ultrasonic measurement (direct and indirect methods) along the shaft and the capital of the column.

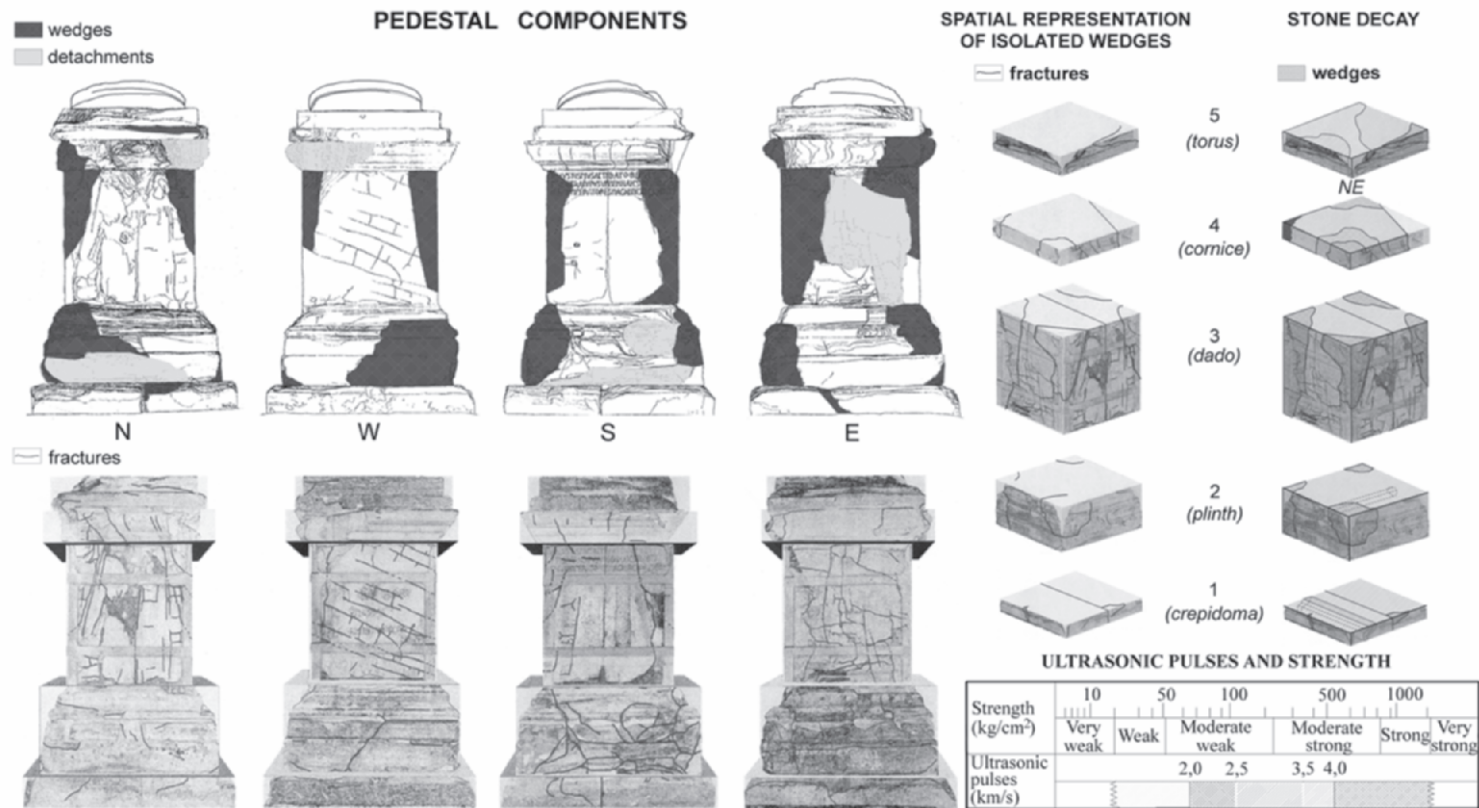
Figure 16. Failure and stone decay classification of the pedestal detected by ultrasonic measurements.

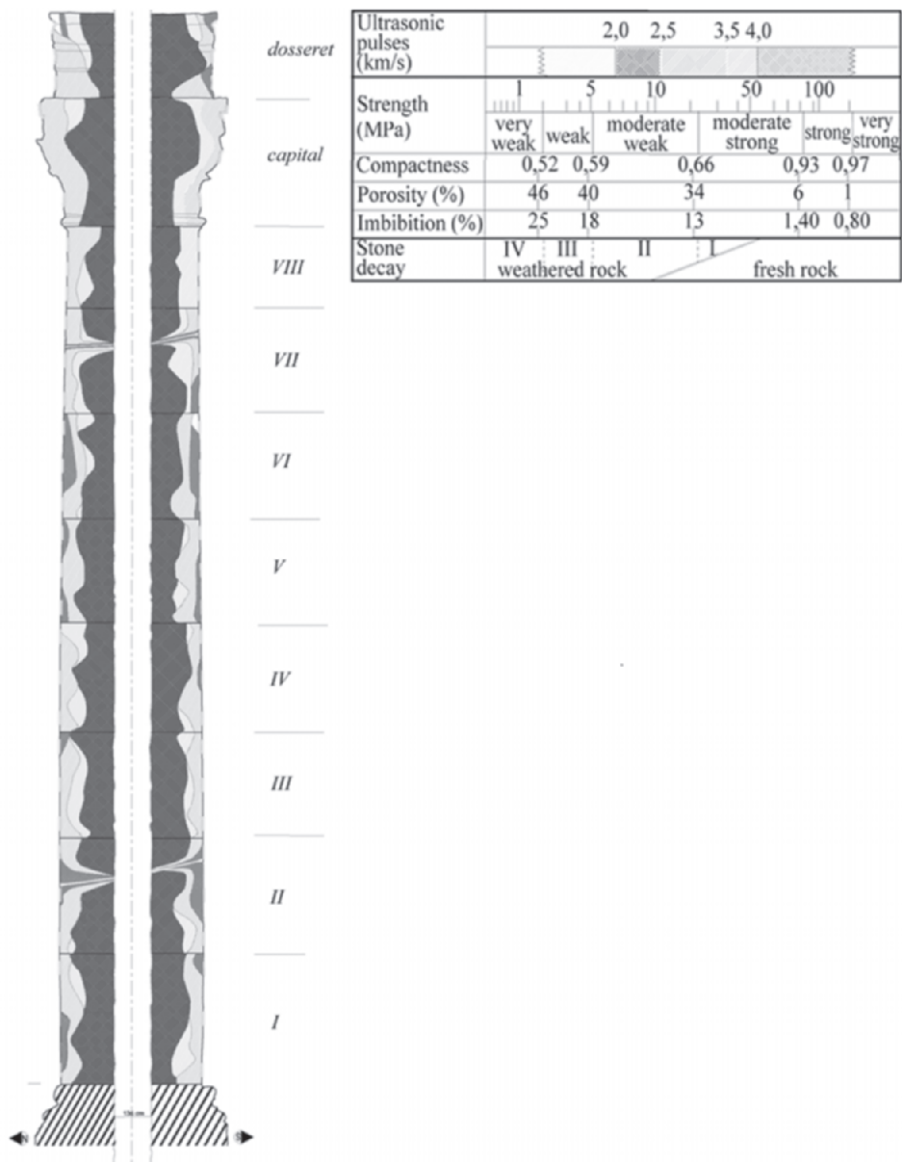
Figure 17. Stone decay classification of the column (shaft and capital) detected by ultrasonic measurements (indirect method).

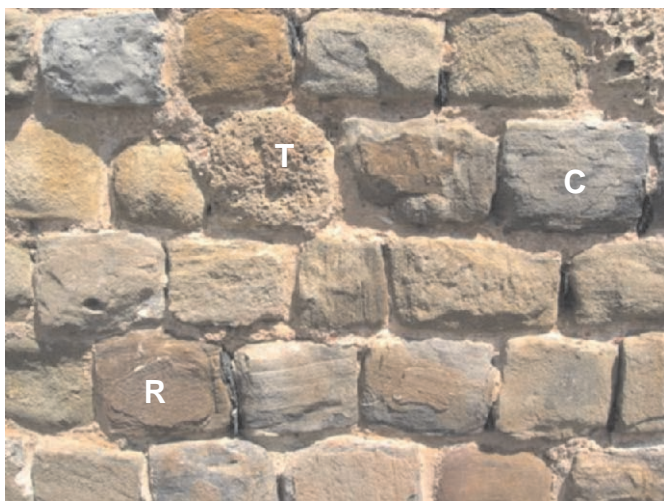
*Figure 1.* Brownish red Roman sandstone (R), together with grey Carboniferous sandstones (C) and pale calcareous tufa (T). These are recycled ashlars from destroyed 2<sup>nd</sup> century Roman villas, actually used in the lower part of the Romanesque tower of the St-Martins church of Rutten, near Tongeren.

In a few cases, a petrographical investigation was the only way to trace the probable origin of particular natural building stones. This was the case for the "Roman" sandstone ashlar (Figure 1) commonly used in Roman and

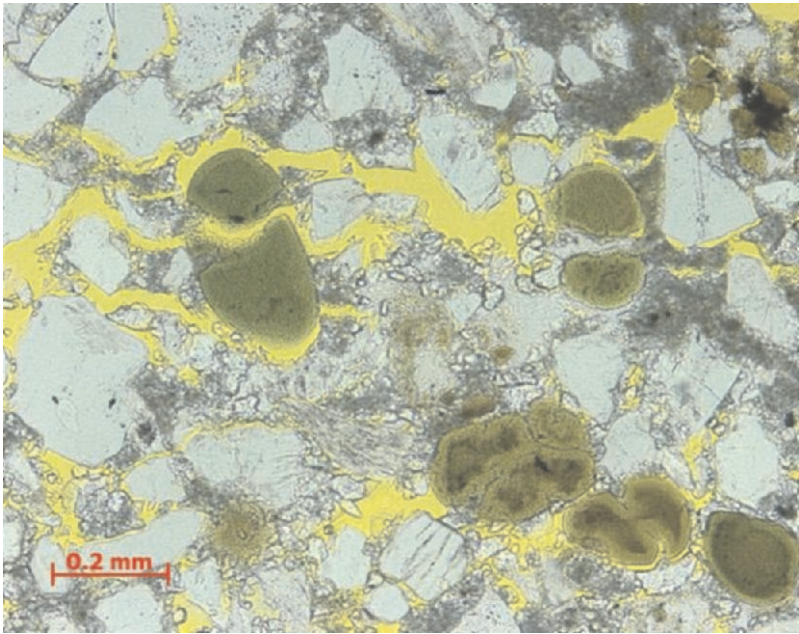
*Figure 6.* Frost-damaged Balegem stone. Micrograph displaying fracturing of lobate glauconite grains due to frost damage. Normal transmitted polarised light. Macro-porosity is highlighted by the use of a yellow dyed epoxy.

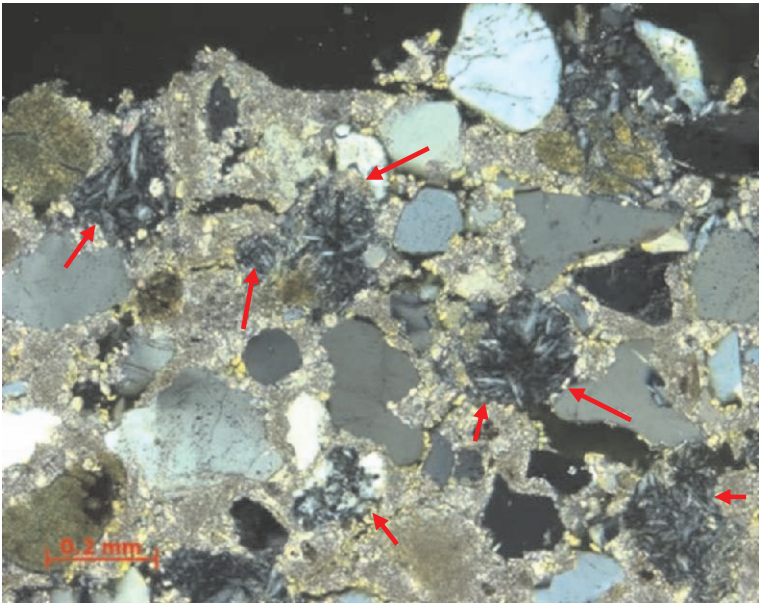
Figure 8. Frost-damaged Balegem stone displaying evidence for sulfate attack. Micrograph shows mouldic porosity completely obliterated by the infilling of fibrous gypsum crystals (arrows). The ovoid gypsum concentrations correspond to weathered and dissolved glauconite grains. External surface is at the top.

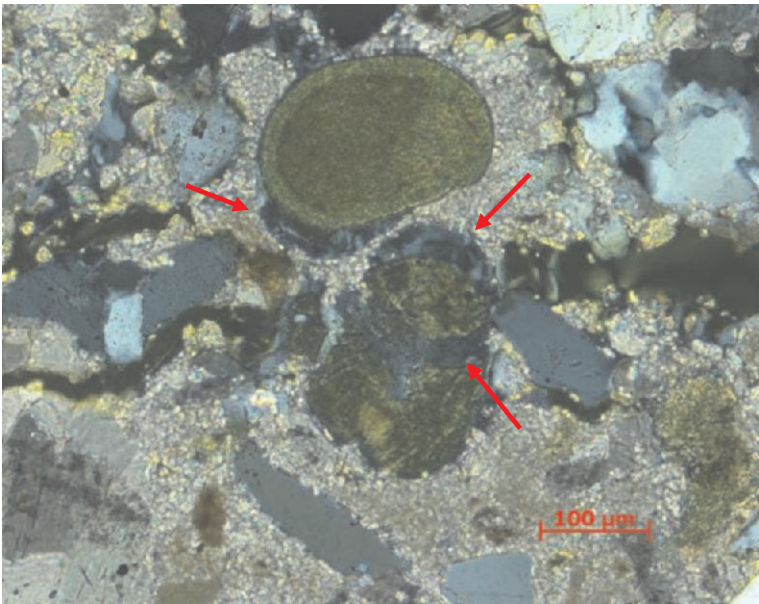
Figure 9. Micrograph showing the preferential precipitation of gypsum in direct vicinity of glauconite grains, both in the frost micro-cracks as in the circum-granular micro-cracks. Polarized transmitted light with crossed polarizers.

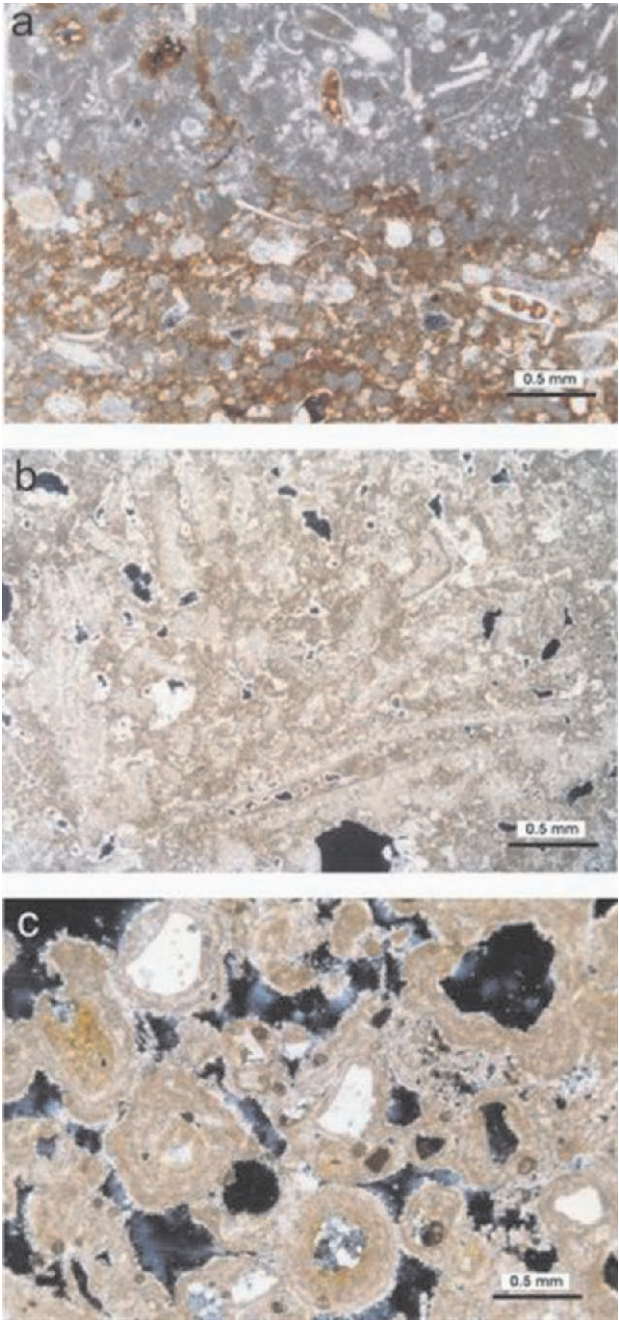
*Figure 2.* Microscopic image of Hungarian limestones showing various types of calcite cement and pore structures: (a) compact limestone with micritic calcite that contains small pelagic bioclasts and ferrous stylolites (lower part) showing no visible pores; (b) travertine with partly cemented pores and phytoclasts ; (c) oolitic limestone with minor cement between ooids and large irregular interconnected pores (black areas represent open pores).

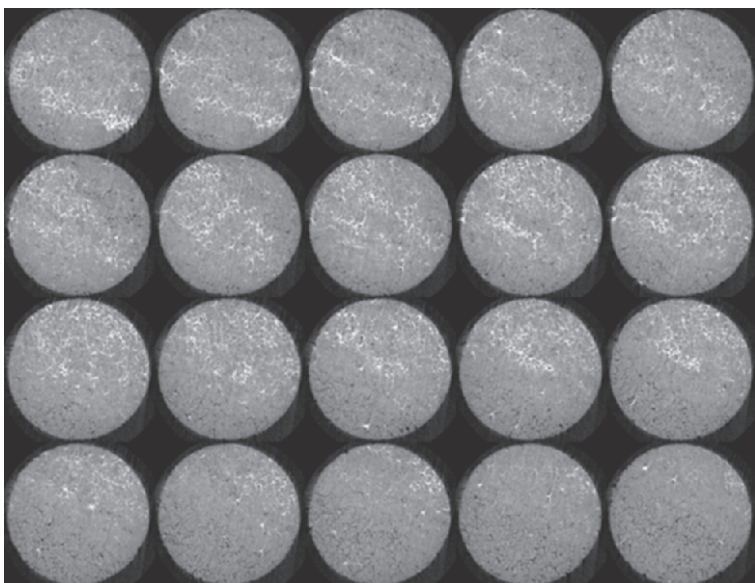
Figure 4. X-ray micro-CT reconstructions indicating a heterogeneous spreading of doped Hydro10 inside the Bray sandstone.

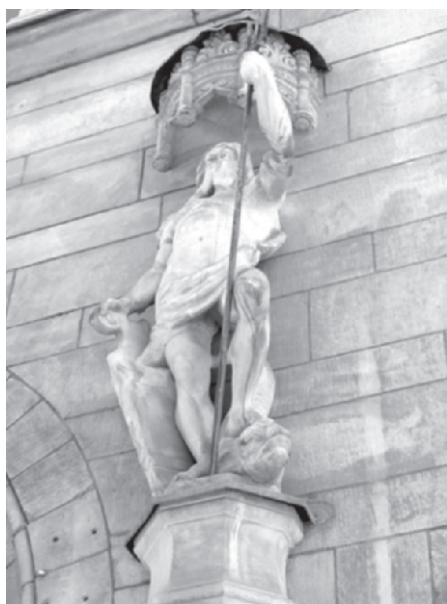
*Figure 2.* Neptunus, Landbyska Verket, Stockholm.

The hydro-protective treatment of the sculpture was made in 1994 using the Wacker product E41. The sculpture is extremely exposed to direct rain and snow. Evident signs of sanding were observed on a few especially exposed areas. When testing the wet-ability of the sanding areas it was observed that the areas had an almost water-repellent surface. The less exposed areas showed no signs of sanding; these areas had a virtually water-repellent surface. Two sampling areas were measured, one area showing no signs of deterioration, which had no water absorption at all after one hour measuring, and one area showing signs of superficial sanding, which absorbed about 0.14 kg/m<sup>2</sup>h (Figure 2) .

Evident dark traces from water running from the trident were observed. These dark traces are most probably due to the fact that the water-repellent agent changed the surface tension and forced the dirty water to run off from the surface in small concentrated veins. No other colour changes or negative effects of the treatment could be observed. The conservation work included extensive reconstruction work. The reconstructions apparently were in a good condition. However, smaller repairs, e.g. technical mending, need to be exchanged. The conclusion of the evaluation is that the sculpture is in need of re-conservation (Figure 2).

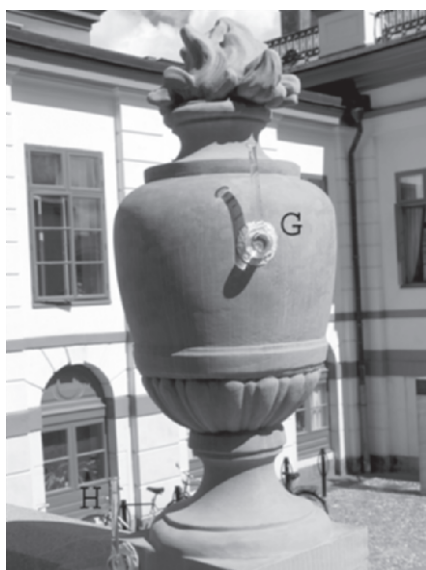
Figure 4. Urns at Bondeska palatset, Stockholm.

The hydro-protective treatment of the decorations was made one year ago (2004) using Wacker E41. The two urns are very exposed to rain and snow and signs of sanding were observed only one year after conservation. The urns had a relatively high absorption of water,  $0.71 \text{ kg/m}^2\text{h}$  and  $0.57 \text{ kg/m}^2\text{h}$ . Colour changes were observed, in the form of thin, white veins running in the direction of the rainwater and covering the stone surface. The conclusion of the evaluation is that the urns are not yet in need of re-treatment but should be checked regularly for signs of further weathering. (Figure 4)
